INDOOR AIR QUALITY ASSESSMENT

**Cold Spring Elementary School
57 Main Street
Belchertown, Massachusetts**

Prepared by:
Massachusetts Department of Public Health
Bureau of Environmental Health Assessment
Emergency Response/Indoor Air Quality Program
October 2003

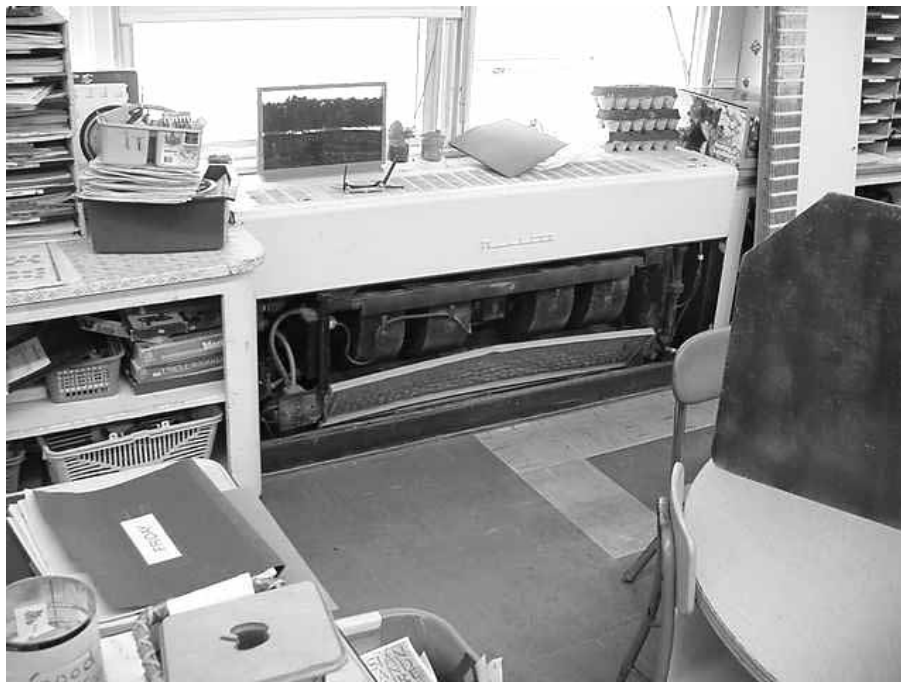
Picture 1

Fresh air in classrooms is supplied by a unit ventilator (univent) system (Picture 1). Univents are designed to draw air from outdoors through a fresh air intake located on the exterior wall of the building and return air through an air intake located at the base of each unit ([Figure 1](#)). Fresh and return air are mixed, filtered, heated and provided to classrooms through a fresh air diffuser located on the front of the unit. Univents were found deactivated, preventing a continuous source of outside air. In addition, shrubbery located around the perimeter and growing in close proximity to the building was obstructing fresh air intakes (Picture 2). In order for univents to provide fresh air as designed, the units must be activated and allowed to operate. In addition, univent air intakes, diffusers and return vents must remain free of obstructions.

Univent

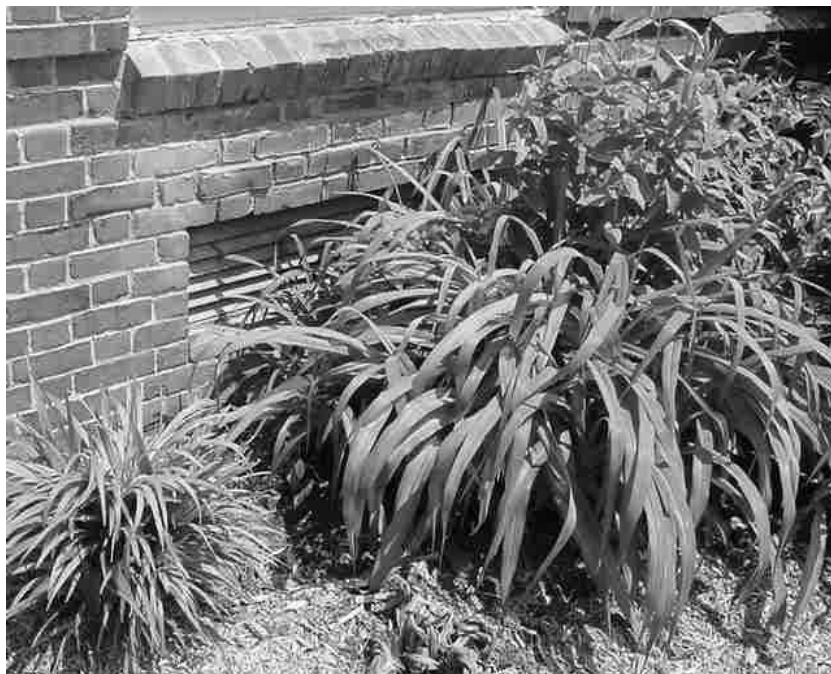
Picture 2

Plants Growing in Close Proximity to Univent Fresh Air Intake

- 9) Remove plant from close proximity of univent fresh air intakes.
- 10) Take steps to prevent prolonged moisture contact with the foundation. These steps may include:

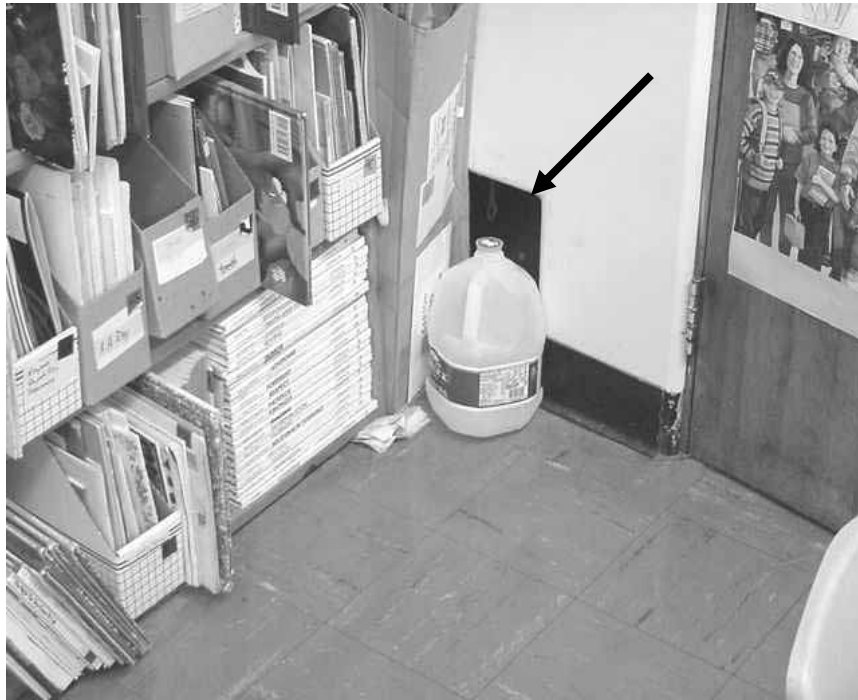
Picture 3

Exhaust ventilation is provided by open holes or “intakes” located along interior classroom walls (Picture 3). The location of these intakes allows them to be easily blocked by stored materials. As with the univents, in order to function properly, exhaust vents must remain free of obstructions.

Exhaust Vent

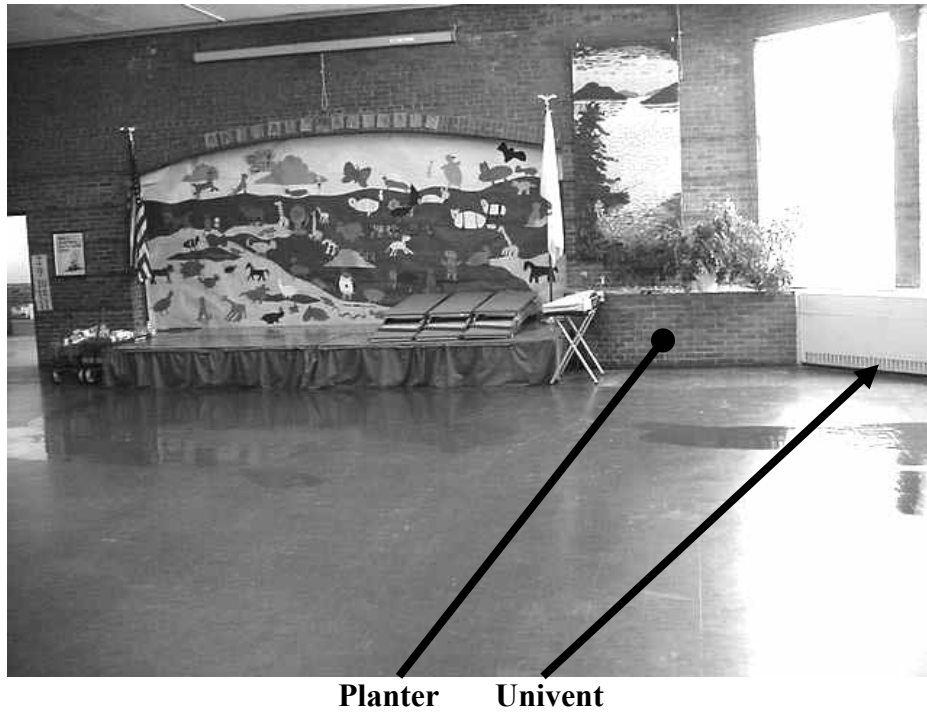
Picture 4

Of concern were reports of musty odors and respiratory symptoms experienced by occupants residing in the PT Room. The PT Room was created through the erection of a permanent wall behind the stage in the Lunch/All Purpose Room (Picture 4). A number of conditions make the PT Room prone to musty odors:

Permanent Wall Erected on Stage to Create the PT Room, Note Location of Planter and Univent

- 2) Examine the feasibility of providing mechanical ventilation for the PT Room.
- 3) Examine the feasibility of installing a mechanical exhaust fan on the airshaft for the Lunch/All Purpose Room.
- 4) Replace water-damaged ceiling tiles. These ceiling tiles can be a source of microbial growth and should be removed. Source of water leaks (e.g., window frames and roof) should be identified and repaired. Examine the non-porous surface beneath the removed ceiling tiles and disinfect with an appropriate antimicrobial.
- 5) Replace caulking around windows to prevent water-damage and the subsequent colonization of wooden windowsills by mold. Consideration should be given to replacing window systems as detailed in the Belchertown Public Schools Five Year Capital Improvement Plane (BPS, 2002).

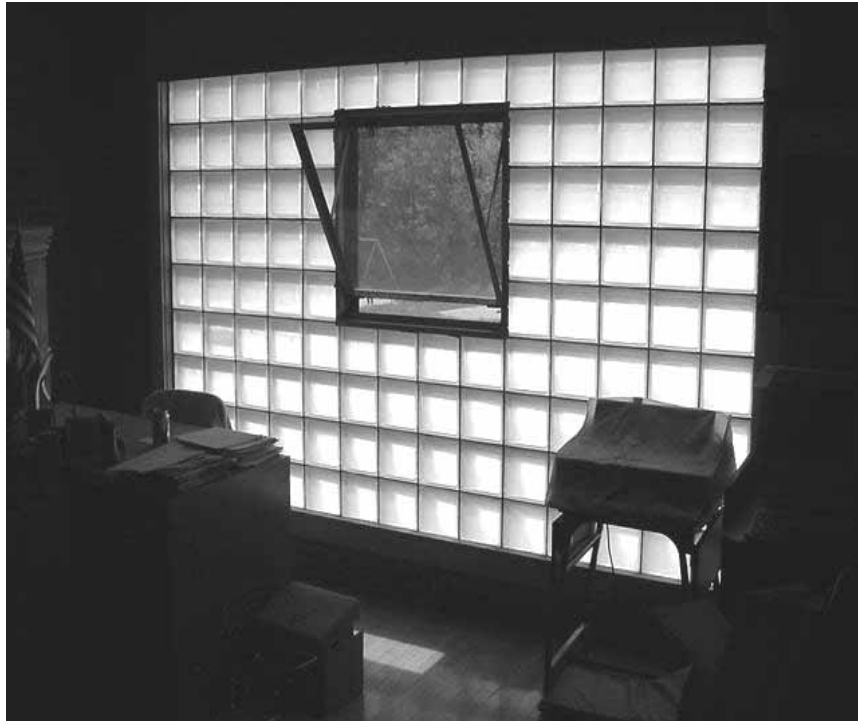
Picture 5

- The glass block window system makes this room prone to overheating when in direct sunlight. Heat would be expected to linger within this space due to a lack of ventilation.

Window in Glass Block Window System in PT Room

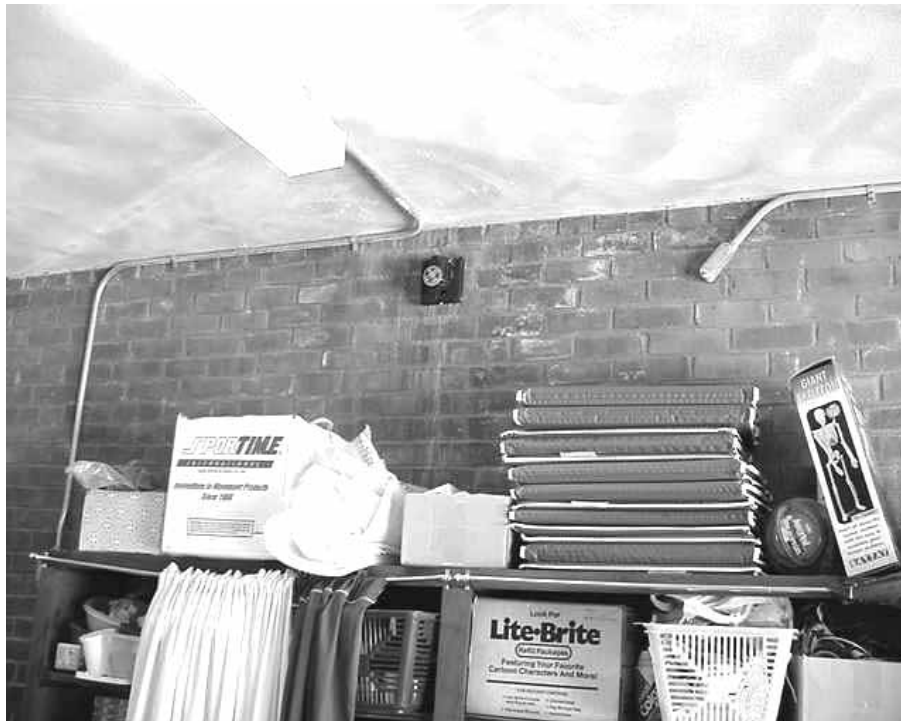
Picture 6

- Signs of water staining/penetrating from the ceiling to the area behind a permanent wood bookshelf were noted (Picture 6). Efflorescence was noted on the brick wall. Efflorescence is a characteristic sign of water damage to brick and mortar, but it is not mold growth. As moisture penetrates and works its way through mortar around brick, water-soluble compounds in bricks and mortar dissolve, creating a solution. As the solution moves to the surface of the brick or mortar, the water evaporates, leaving behind white, powdery mineral deposits. Brick and mortar are not good mold growth media. In contrast, wood can be a mold growth medium, particularly if repeatedly moistened, without drying.

Water Damaged Ceiling and Wall, PT Room

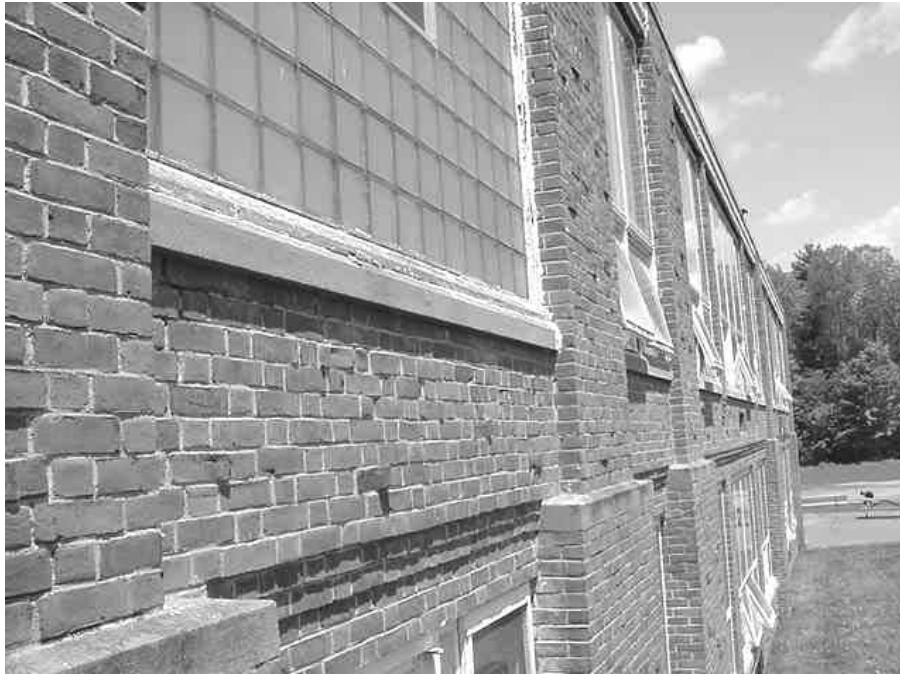
Picture 7

- Signs of water staining/penetrating below the window block system. This can indicate that moisture is accumulating in the space below the stage floor. The exterior junction between the window block system and the exterior show signs of erosion/deterioration (Picture 7). This can serve as a water penetration pathway.

Exterior Junction between the Window Block System and the Exterior Show Signs or Erosion/Deterioration

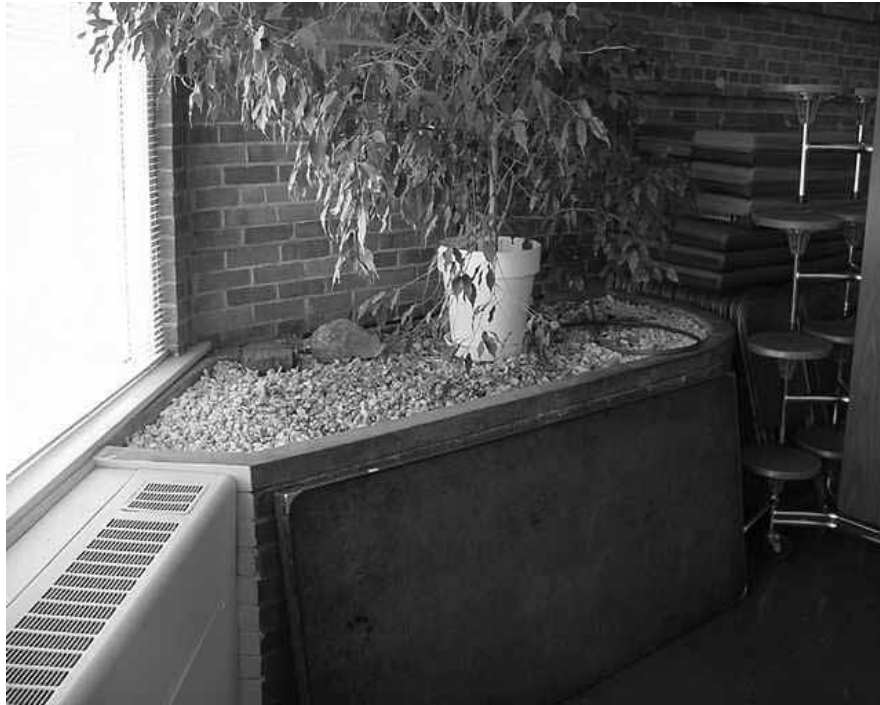
Picture 8

- Built-in brick wall planters are located in the Lunch/All Purpose Room next to the stage (Picture 8). These planters are devoid of living plants but are filled with dirt (Picture 9). It could not be determined whether any of these planters have adequate drainage. Plant soil can be a source of particulates, such as mold, which can be a respiratory irritant to some individuals if aerosolized.

Planter in Lunch/All Purpose Room, Note Univent Location

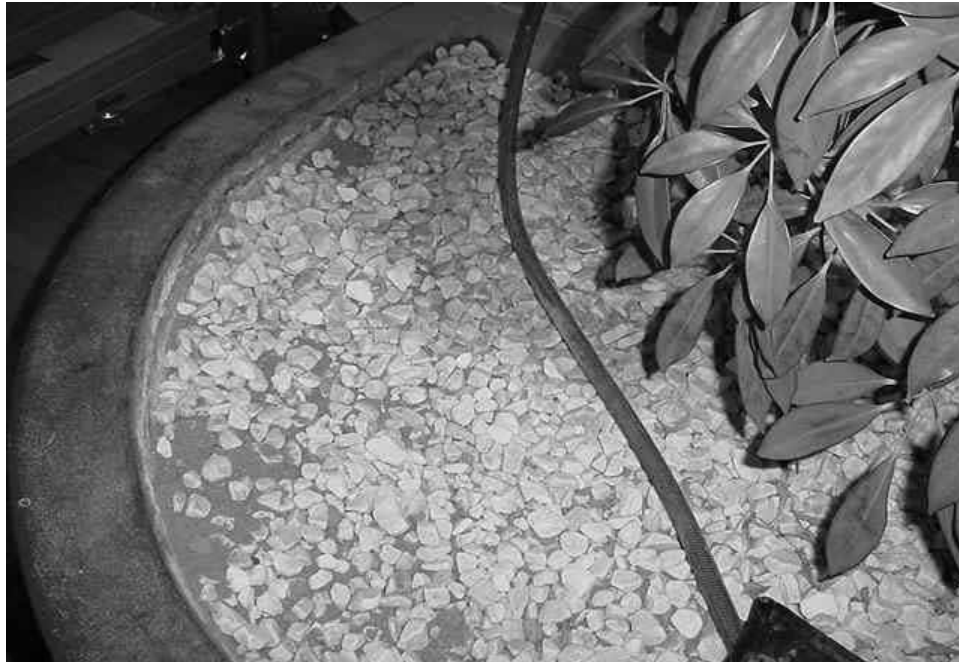
Picture 9

Dirt and Stone in Indoor Planter

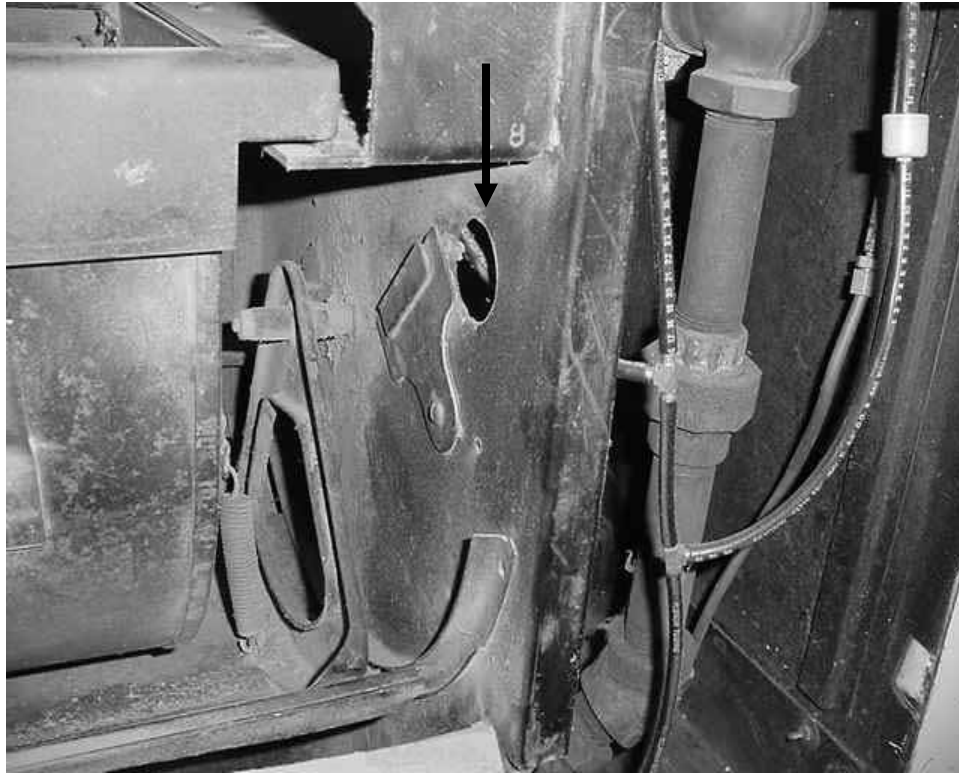
Picture 10

Several pathways exist for crawlspace air to migrate into occupied areas. A crawlspace exists under classrooms to provide a chaseway for univent heating pipes. The interiors of univents were randomly examined. Spaces and holes in walls and floors around pipes and within the air handling cabinet were noted (Pictures 10 & 11). These spaces can serve as pathways to draw air, odors and particulates from exterior wall cavities and the crawlspace into classrooms.

Holes within the Air Handling Cabinet

- 7) Seal all holes in the walls of the univent air handling cabinets to limit filter bypass.
Double sided, foil faced insulation with adhesive can be applied in a manner to create an airtight seal.

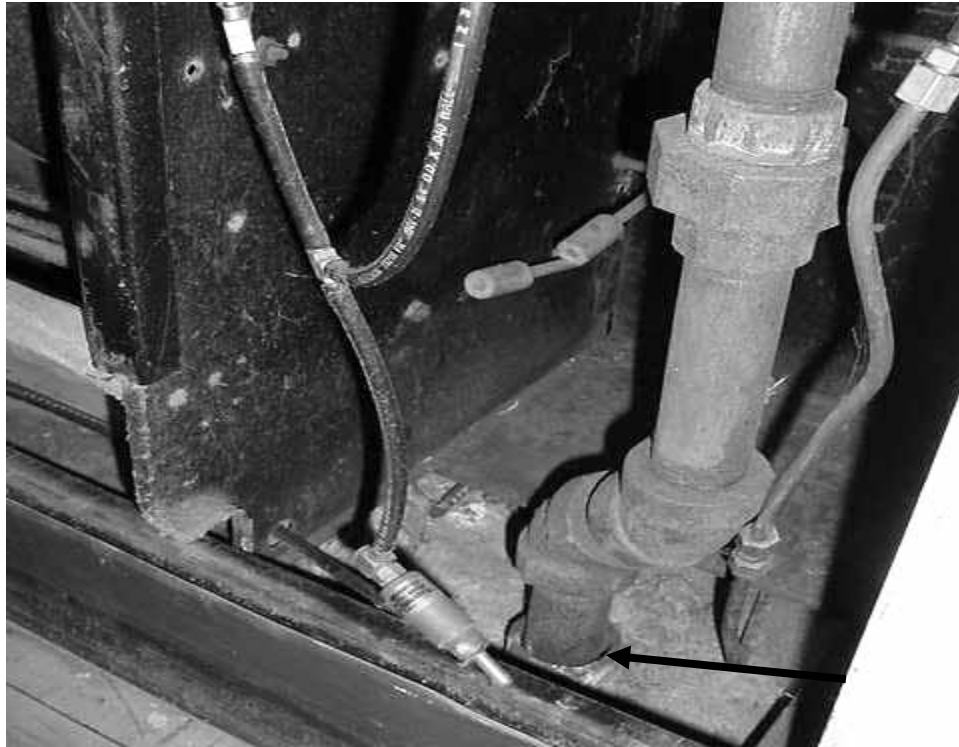
Picture 11

Holes Exist in the Floor for the Univent Heating Pipes

- 8) Seal walls in the rear of each univent cabinet and floor holes to prevent air draw from the exterior wall cavity and crawlspace, respectively. Seal the seams and holes in the crawlspace access hatches with duct tape.

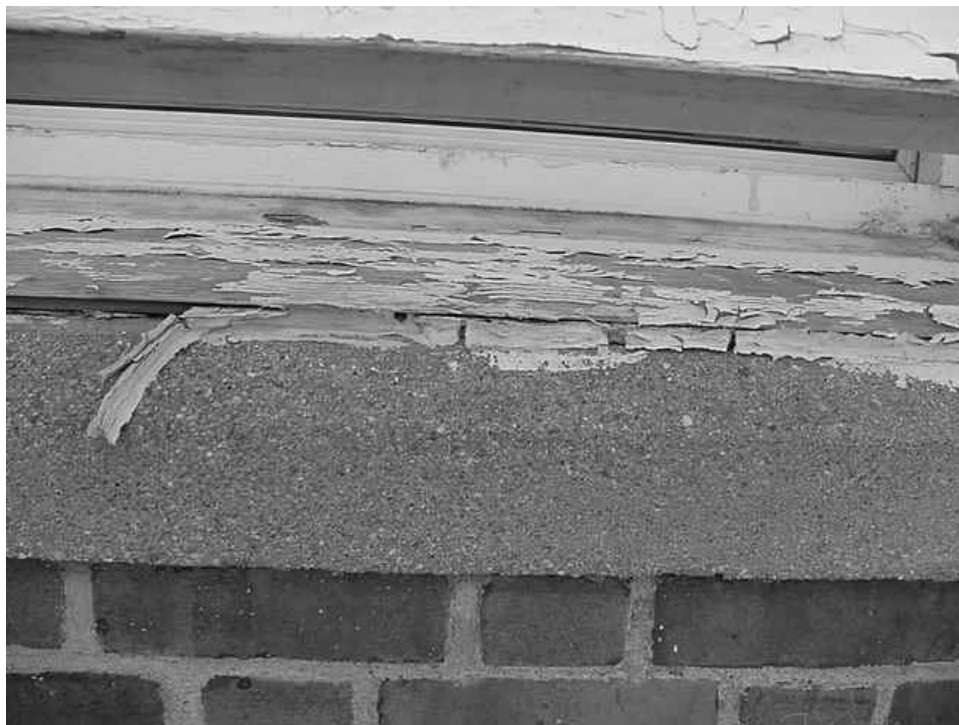
Picture 12

A number of means for water to penetrate the building exist. As previously mentioned, caulking around windows appears to be missing, damaged or crumbling in a number of areas (Picture 12). Window seams should be properly sealed to prevent water intrusion and subsequent mold growth.

Damaged caulking around window

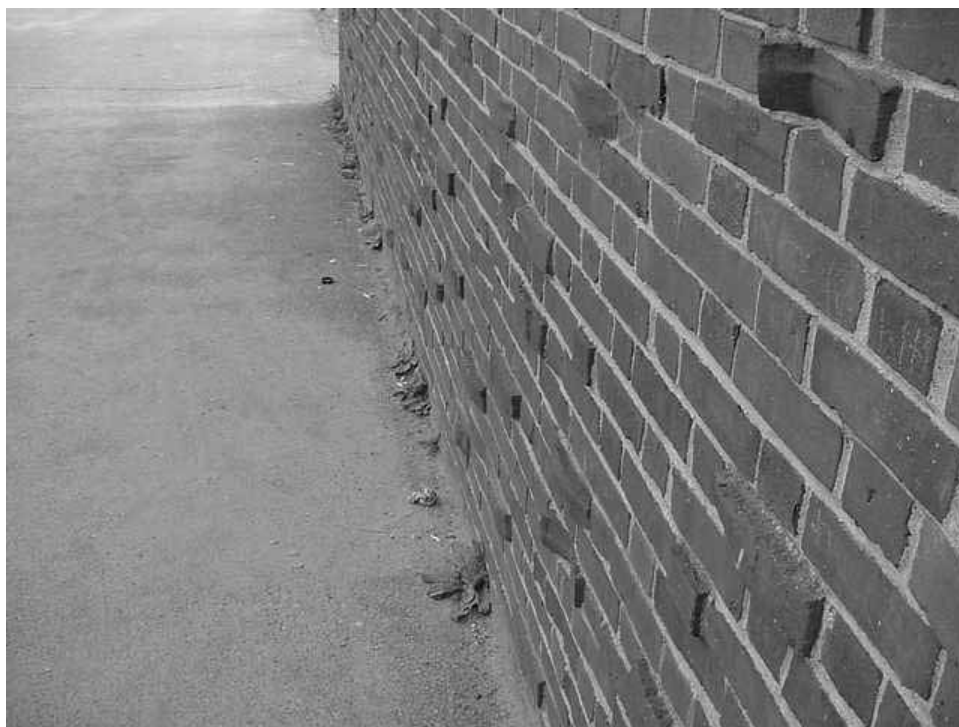
Picture 13

Shrubbery growing in direct contact with the exterior wall brick was noted along the building foundation (Picture 13). In addition, a garden was planted along the west wall of the south wing, in close proximity to the foundation wall on the uphill side of the building (Picture 14). Shrubbery growing directly against the building can serve as a possible source of water impingement on the exterior curtain. Plants also retain water, thus providing an additional source of water that can penetrate a building. Gardens covered with mulch and shrubbery can also hold water against the foundation of a building. These conditions can produce means for water to penetrate below grade areas, such as basements and crawlspaces. In some cases, roots can work their way into mortar and brickwork causing cracks and fissures. Over time, this process can undermine the integrity of the building envelope by providing a means of water entry into the building through capillary action (Lstiburek & Brennan, 2001).

Plants Growing Against Building Foundation

- a) Remove foliage, gardens and mulch to at least five feet away from the foundation.
 - b) Improve the grading of the ground away from the foundation at a rate of 6 inches per every 10 feet (Lstiburek, & Brennan, 2001).

- c) Install a water impermeable layer on ground surface (clay cap) to prevent water saturation of ground near foundation (Lstiburek, & Brennan, 2001).

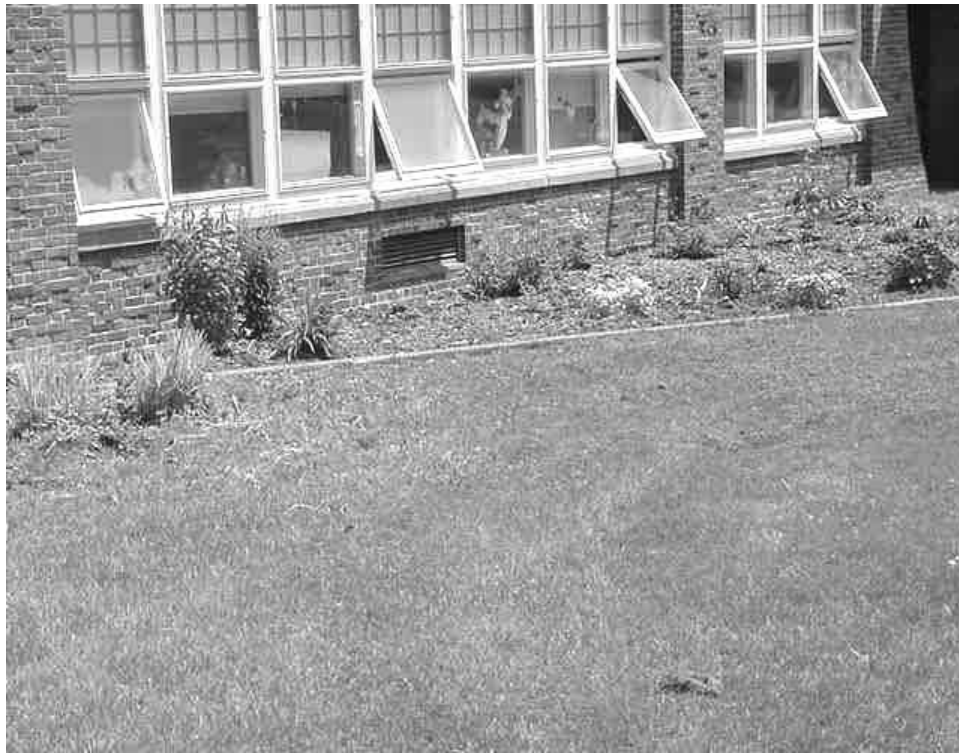
Picture 14

Garden Was Planted Along The West Wall Of The South Wing In Close Proximity To The Foundation Wall On The Uphill Side Of The Building

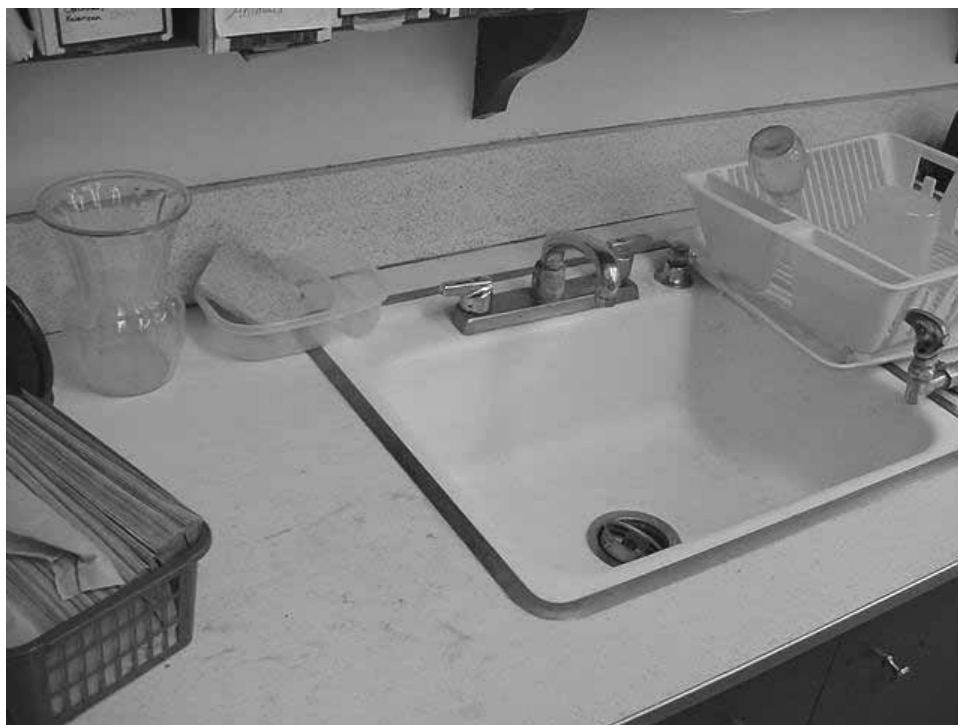
Picture 15

Several classrooms have sinks with a seam between the countertop and wall (Picture 15). If not watertight, water can penetrate through this seam. Water penetration and chronic moisture exposure can cause porous materials to swell and serve as a medium for mold growth.

Seam between Countertop and Baseboard

- 12) Seal areas around sinks to prevent water-damage to the interior of cabinets and adjacent wallboard. Inspect adjacent areas for water-damage and mold growth, repair/replace as necessary. Disinfect areas of microbial growth with an appropriate antimicrobial as needed.

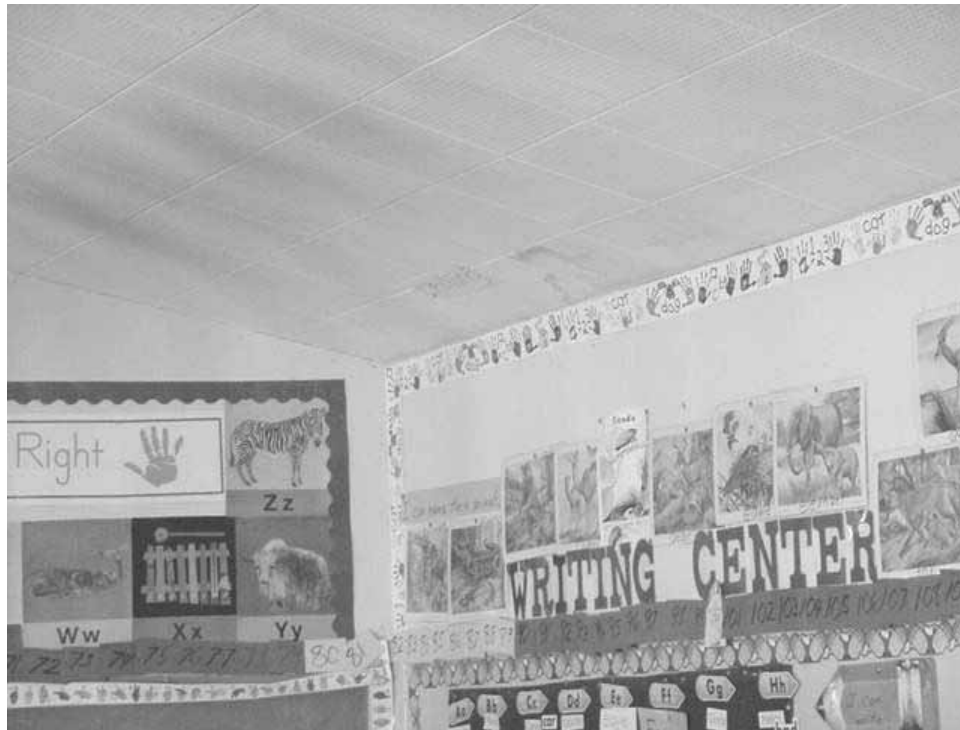
Picture 16

The school has a tile system that is glued directly to the ceiling (Picture 16). A number of classrooms have ceiling tiles that appear to be water-damaged. Replacement

of these ceiling tiles is difficult, since their removal appears to necessitate the destruction of the tile, which can result in the aerosolization of particulates. Water-damaged wall plaster and ceiling tiles may provide media for mold and mildew growth and should be replaced after a water leak is discovered and repaired.

Tile System Glued Directly To the Ceiling, Note Water Stain

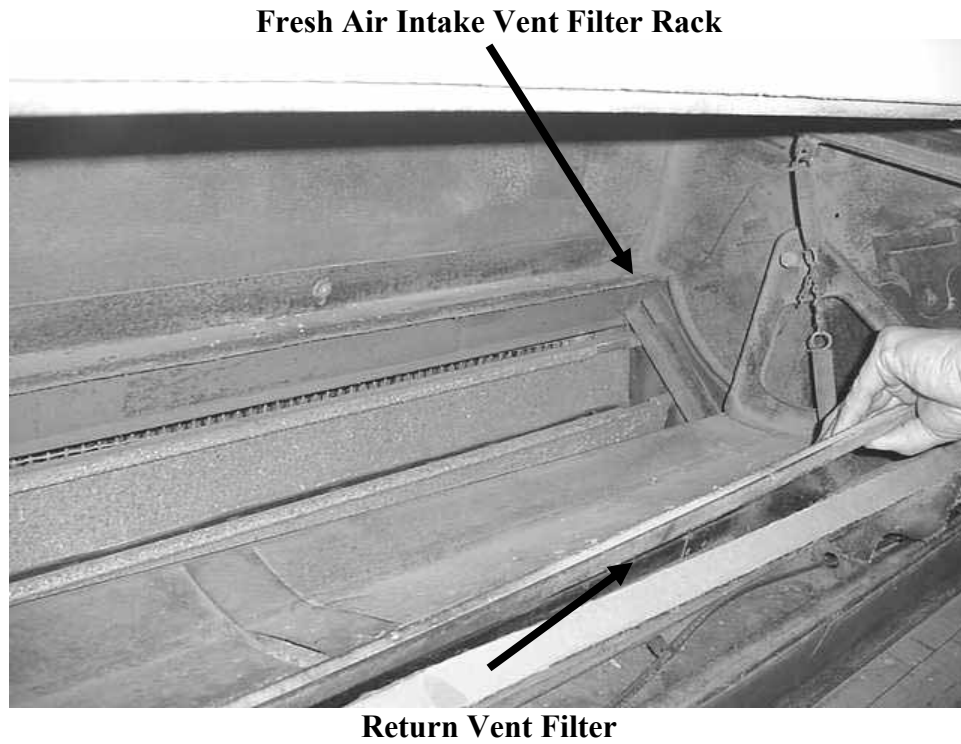
Picture 17

Several other conditions that can potentially affect indoor air quality were identified. Airflow into the univent is controlled by a pendulum type louver that covers both the fresh air intake and return vents. This configuration requires that two separate filters be installed over the fresh air intake and return vents (Picture 17). While the return vent filter appeared to be replaced regularly, the fresh air intake vent filter was missing in several univents examined. In this condition, unfiltered outdoor air is drawn into the univent. Univent fresh air intakes that are low to the ground can draw pollen, mold spores dirt and other pollutant and distribute these pollutants into classrooms.

Unfiltered Fresh Air Intake of Univent

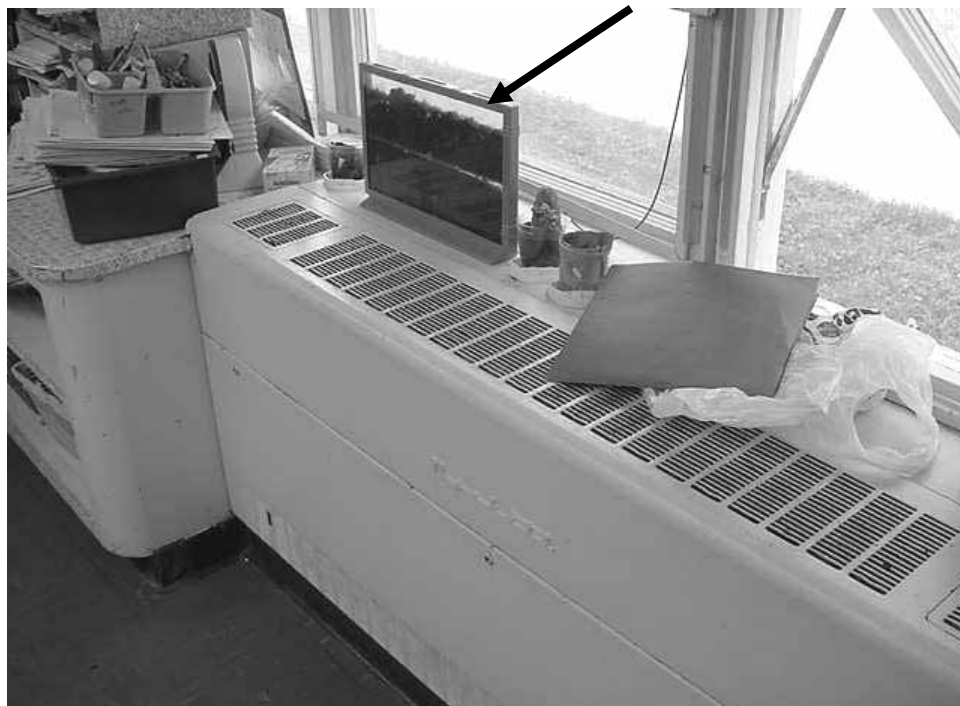
Picture 18

Stored food containers that may attract rodents and other pests were noted in some classrooms. One classroom had an ant farm that had a number of ants outside the container (Picture 18). Another classroom had accumulated milk cartons. Food residues in milk cartons and improperly stored foods can be an attractant for pests. Under current Massachusetts law (effective November 1, 2001) the principles of integrated pest management (IPM) must be used to remove pests in state buildings (Mass Act, 2000). Pesticide use indoors can introduce chemicals into the indoor environment that can be sources of eye, nose and throat irritation. The reduction/elimination of pathways/food sources that are attracting these insects should be the first step taken to prevent or eliminate this infestation and therefore prevent the use of pesticides.

Ant Farm on Univent

- 14) Use the principles of integrated pest management (IPM) to rid the building of pest. A copy of the IPM recommendations from the Massachusetts Department of Food and Agriculture (MDFA, 1996) can be obtained at the following website:
http://www.state.ma.us/dfa/pesticides/publications/IPM_kit_for_bldg_mgrs.pdf.
Activities that can be used to eliminate pest infestation may include the following activities.
